Certificate: 32-A-0774

Legal Name: ENVIGO RMS LLC

Inspection No: 2016090000667813

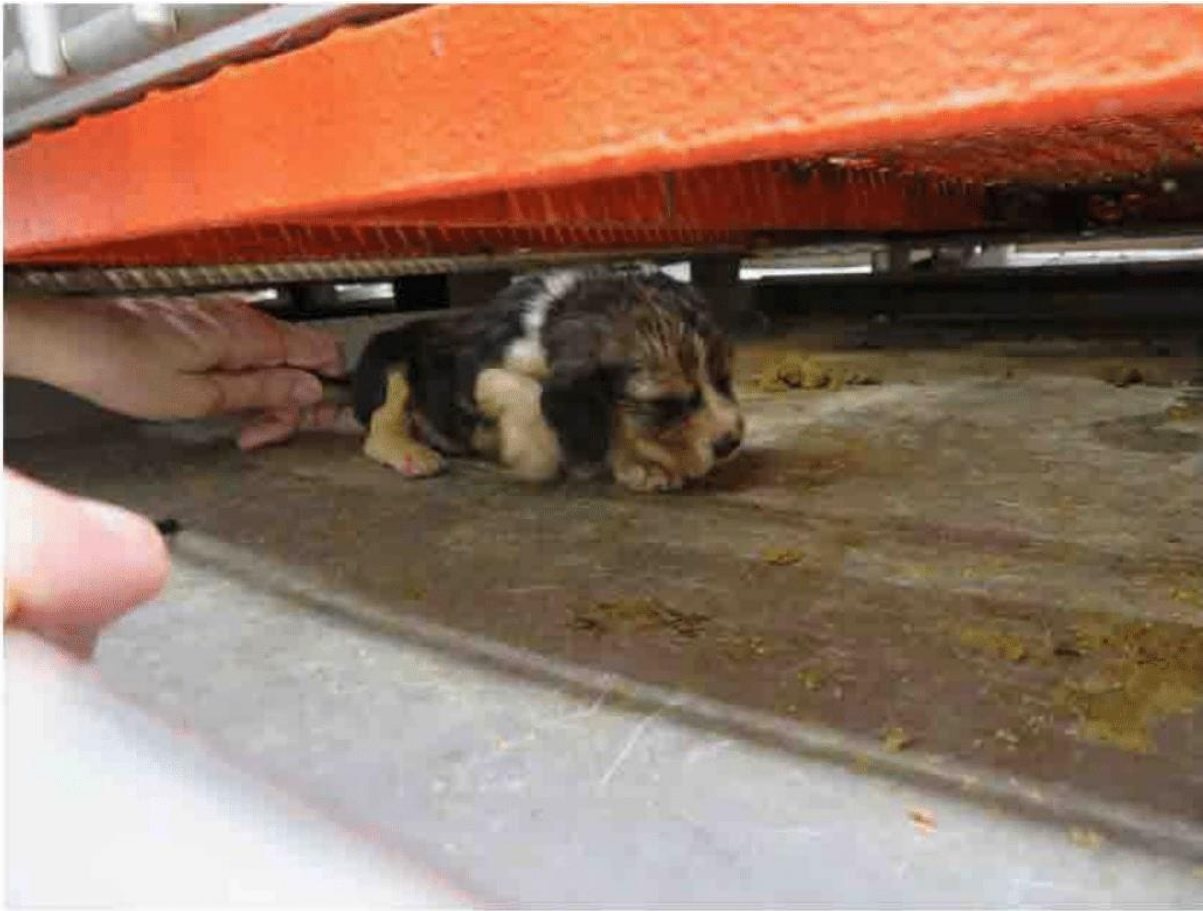
CFR:2.131(b)(1)

Description: A 3-week-old male puppy found in the fecal and urine waste pan below the cage housing his litter and dam. The puppy was not vocalizing or moving when found.

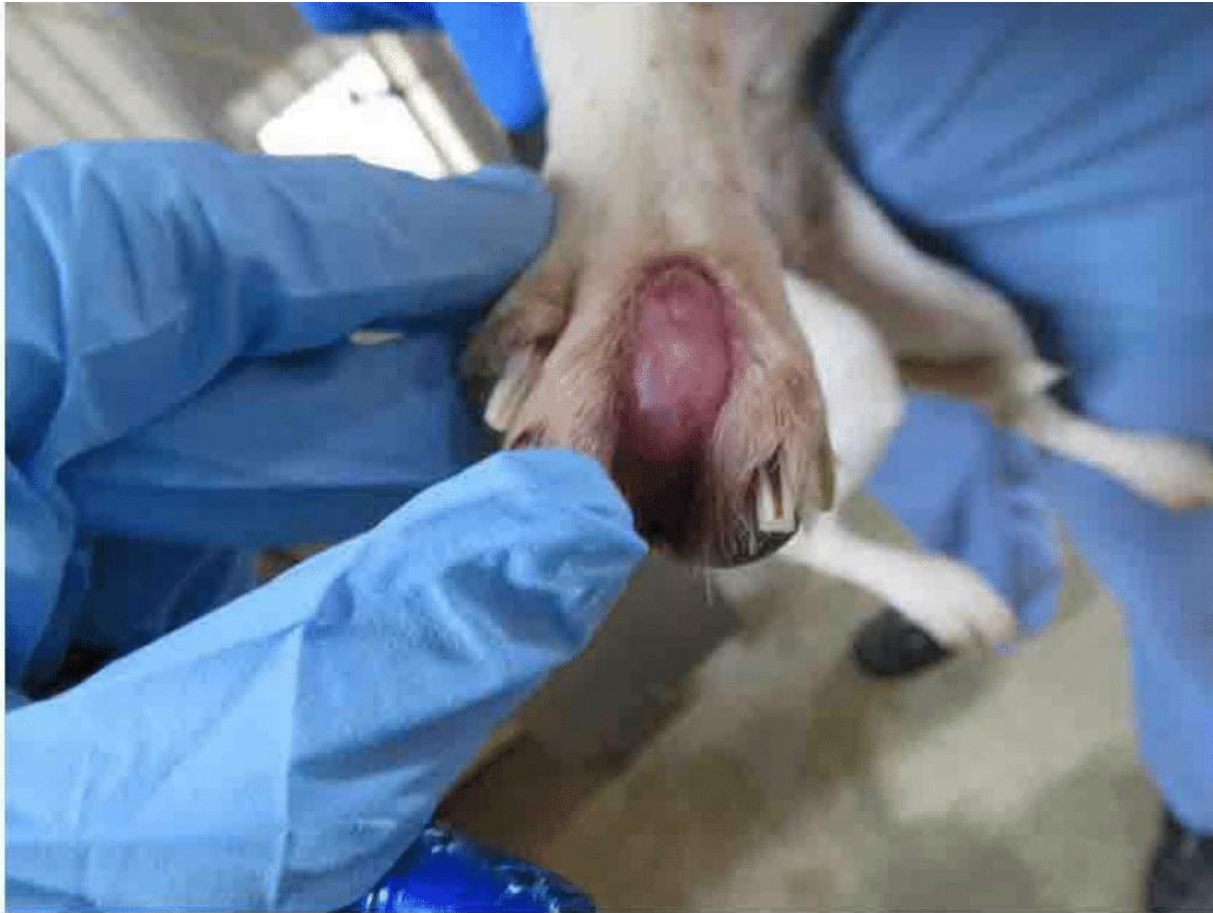
CFR:2.40(b)(3)

Description: In Building G2, Room 1, an adult female beagle (CLACHJ) has a large, firm, pink and swollen area of skin between the middle (center) two toes of her right front paw.

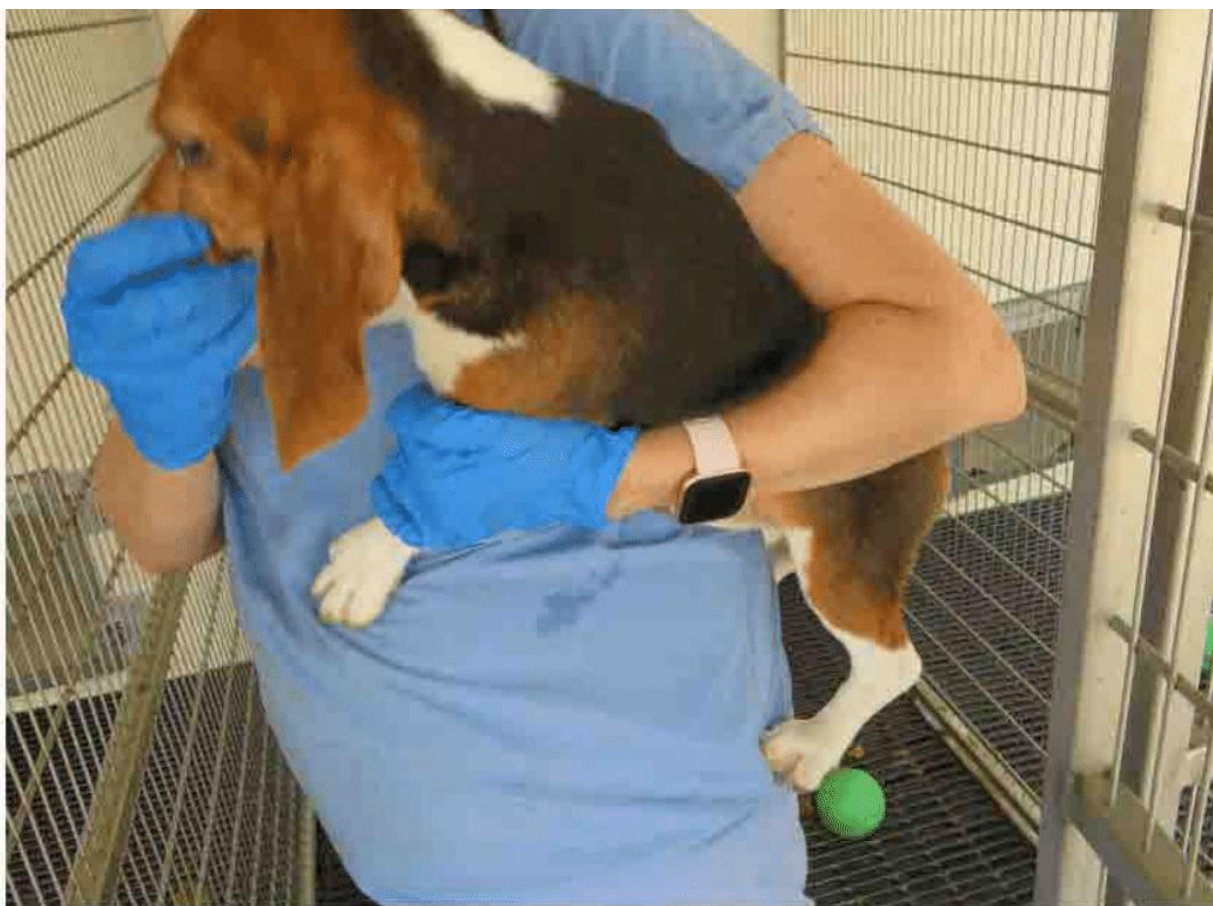
CFR:2.40(b)(3)

Description: In Building G2, Room 5, an adult male beagle (CMBCIA) has discharge in the left eye. The eye has milky, yellow discharge around the edges and there are crusts on the surrounding eyelid.

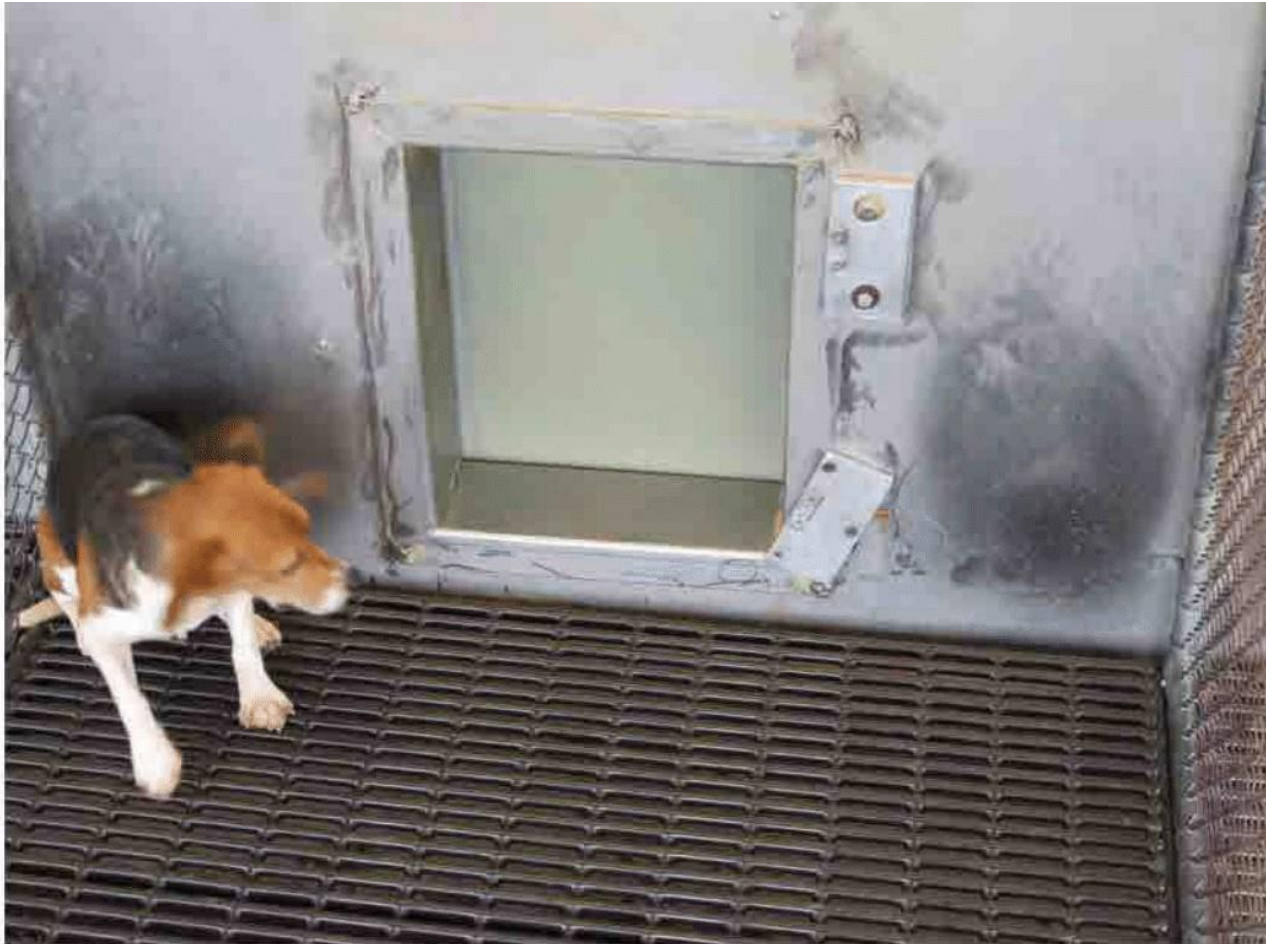
CFR:3.1(c)(1)

Description: plastic door and metal flashing are completely gone, only hinges remain

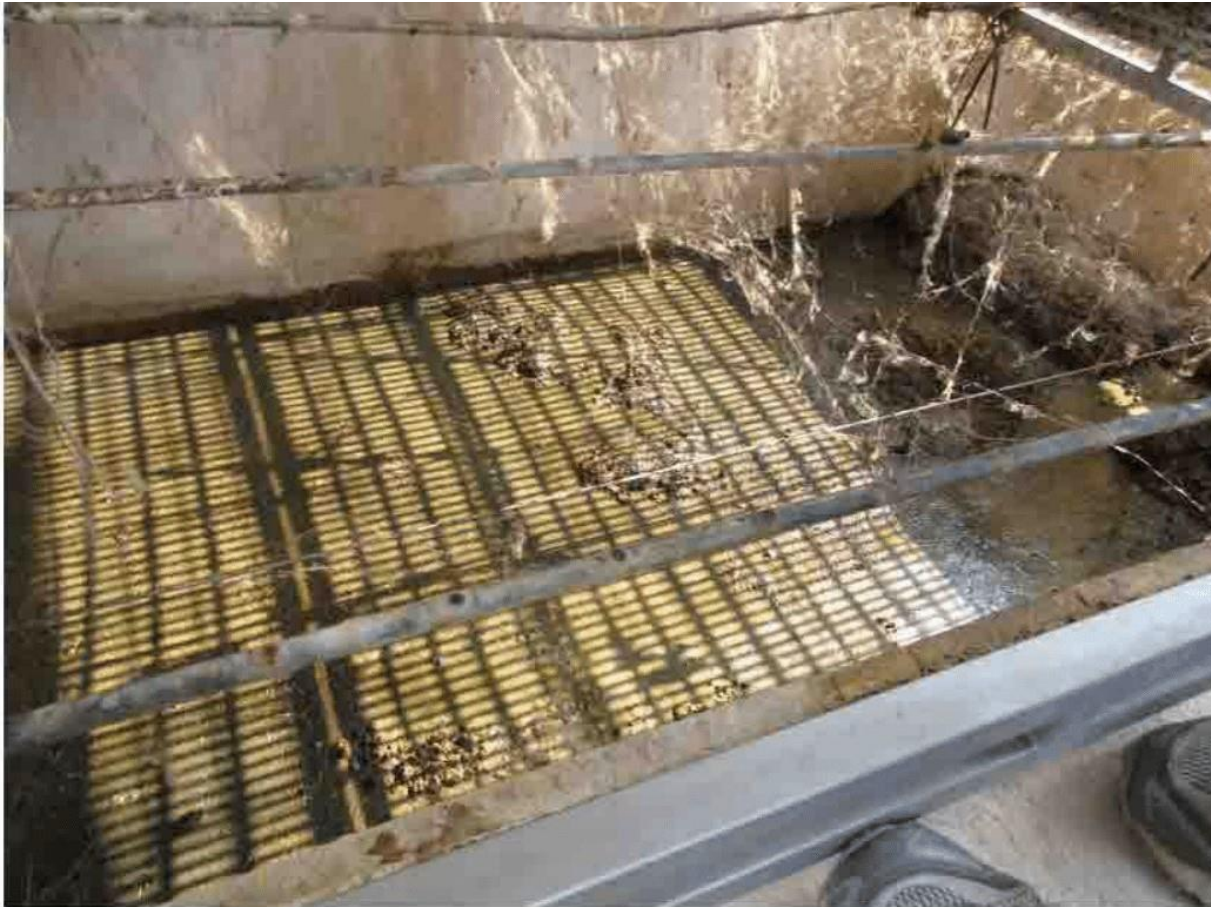
CFR:3.11(a)

Description: Gutter filled with waste material (feces, urine, water) located directly underneath the outdoor portions of the shelter kennels. Spider webs are present as well.

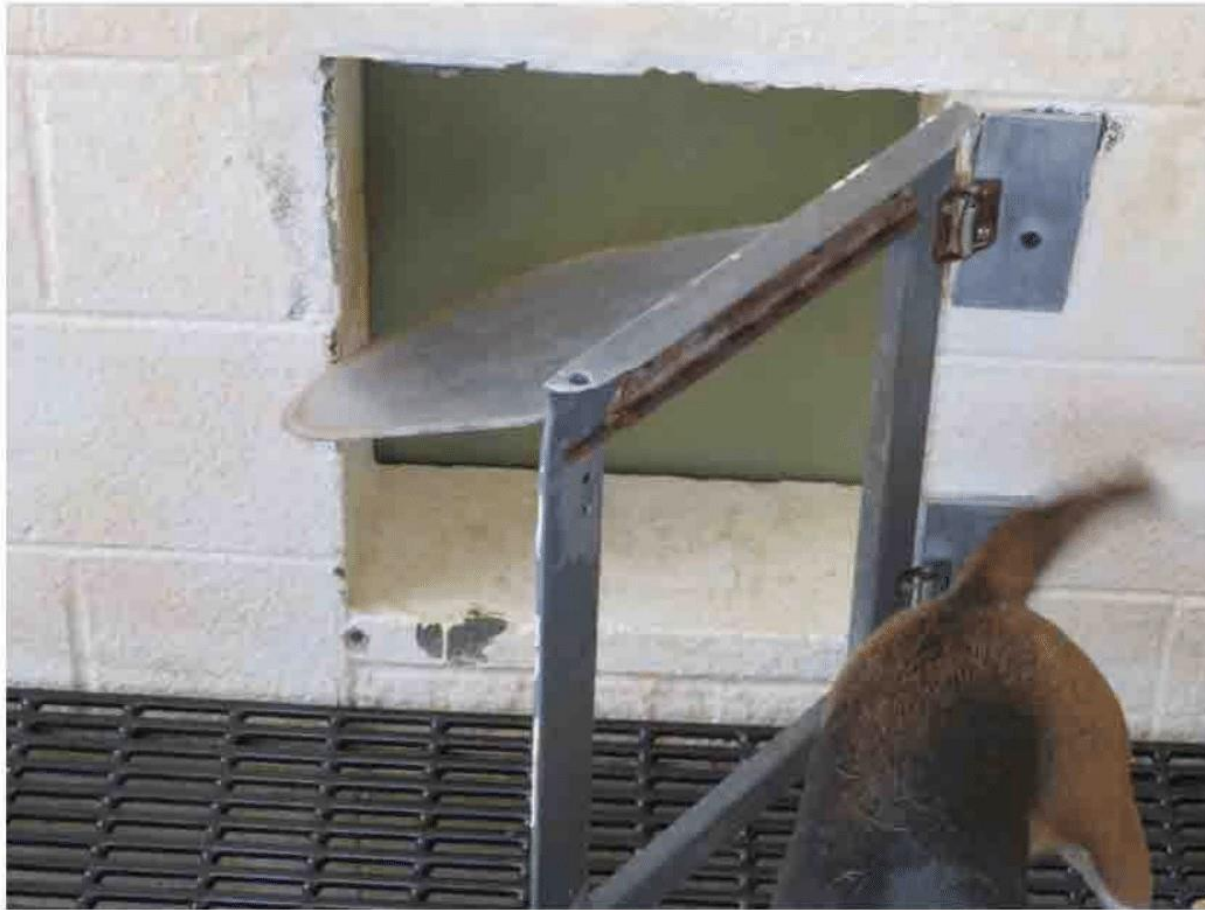
CFR:3.1(c)(1)

Description: Dog door in a sheltered run with a chewed plastic door and damaged metal flashing detached from the cinderblock wall.

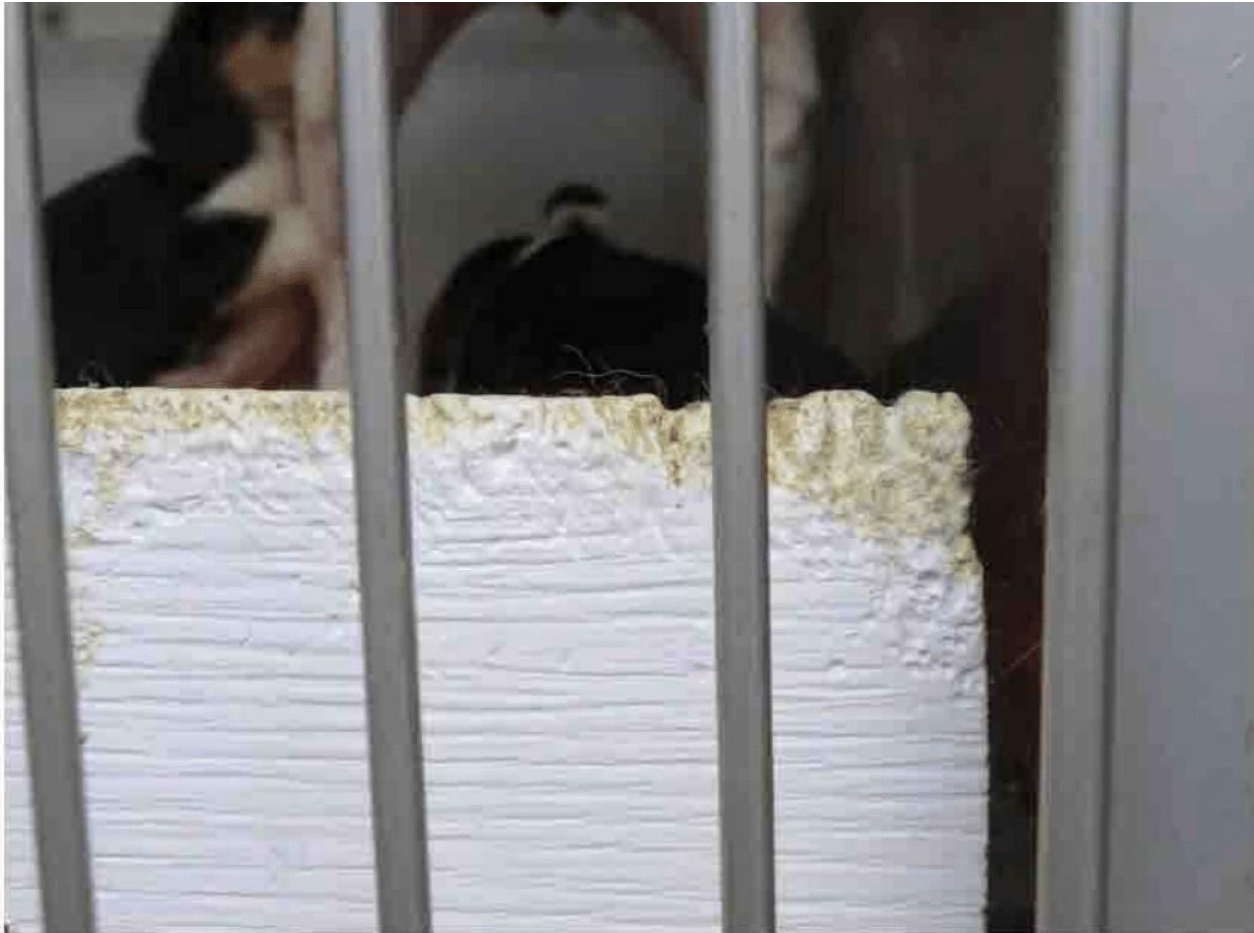
CFR:3.1(c)(1)

Description: Plastic boards with chewed edges placed in whelping kennels.

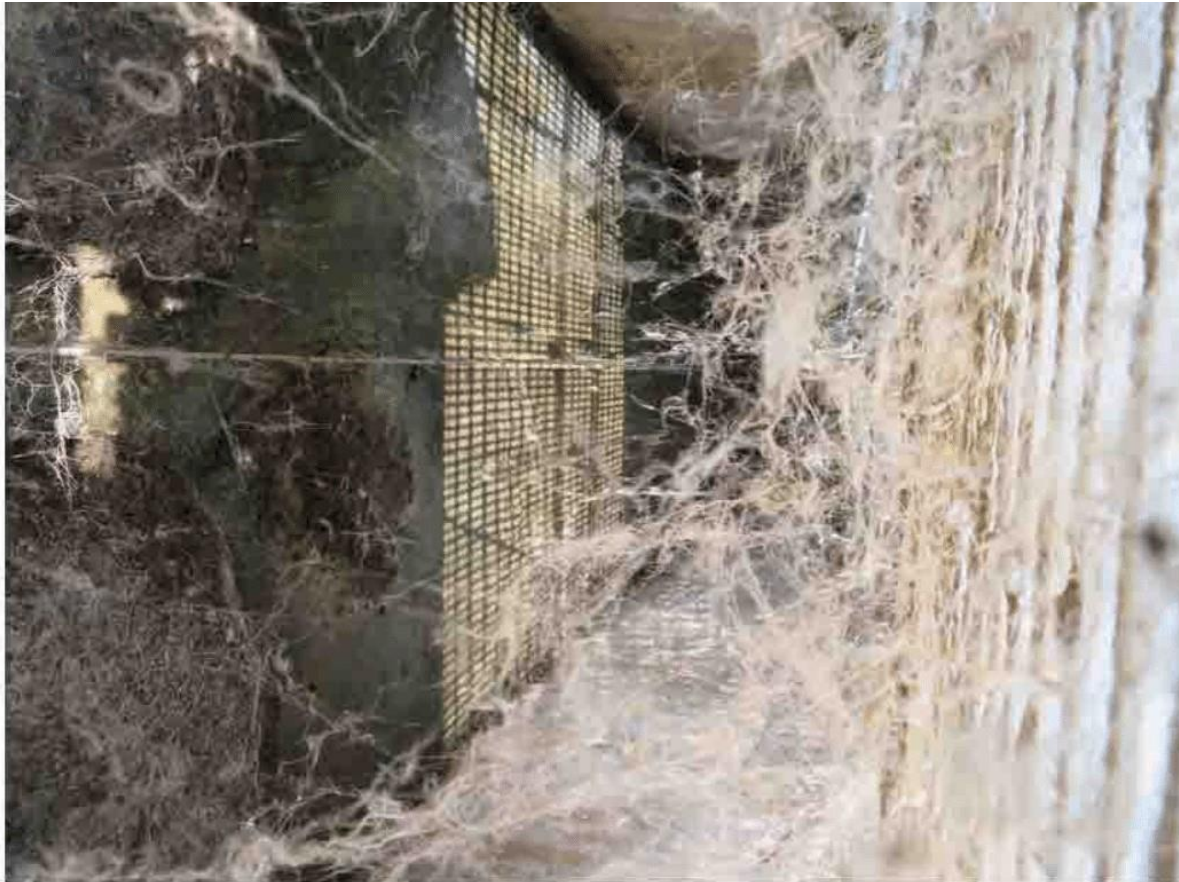
CFR:3.11(a)

Description: Gutter filled with waste material (feces, urine, water) located directly underneath the outdoor portions of the shelter kennels. There are also a lot of cobwebs present in the access point to the gutter, obscuring visualization further down.

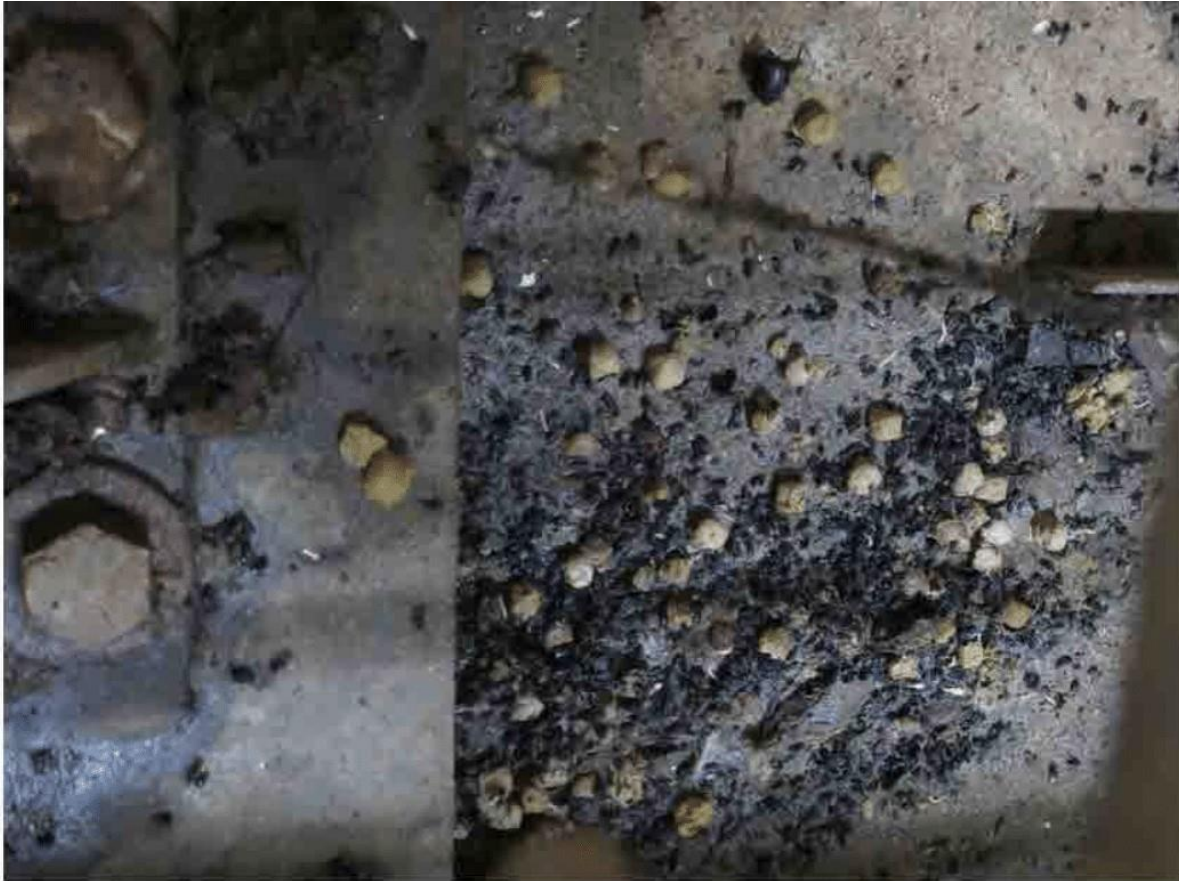
CFR:3.11(a);3.11(d)

Description: Large numbers of dead and alive insects/pests found at the access point to the inside gutter within the sheltered housing.

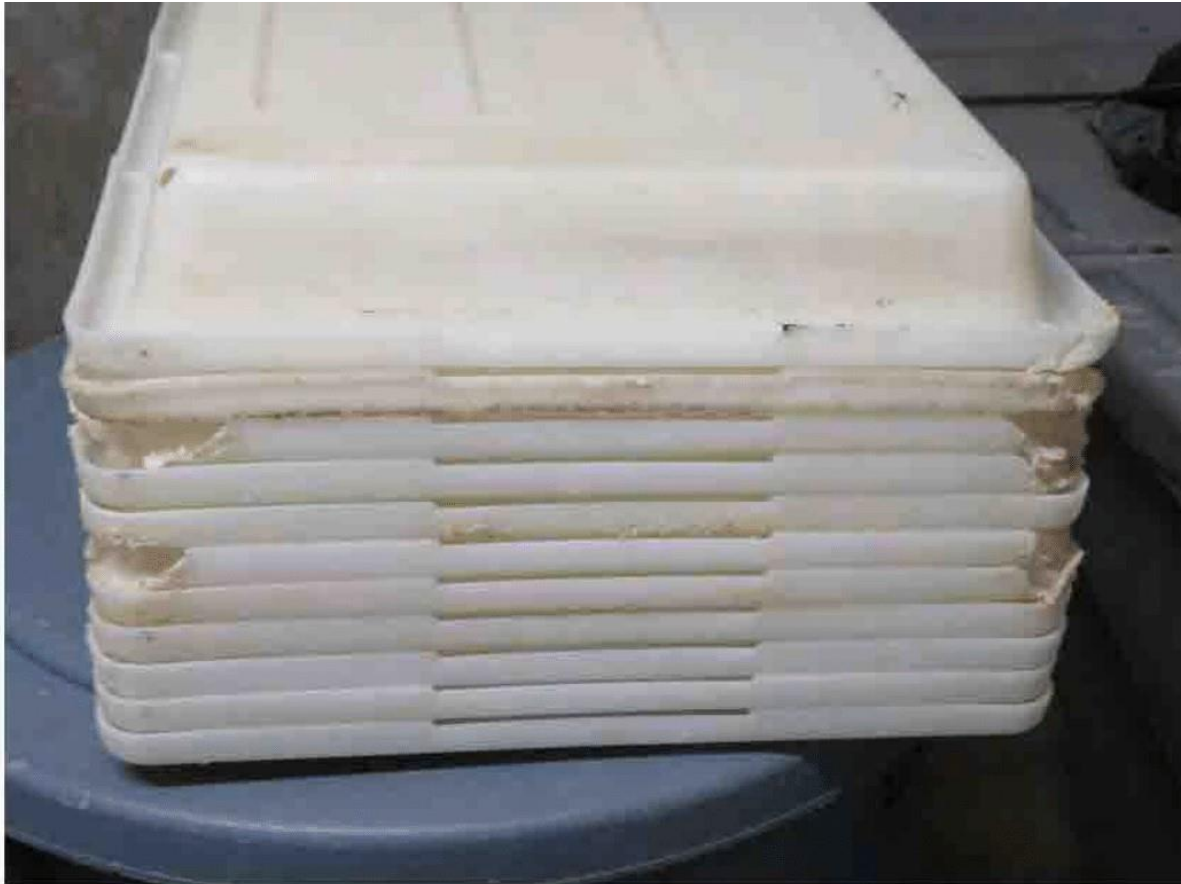
CFR:3.1(c)(1)

Description: Stack of plastic boxes ready to be placed into kennels with whelping dams. Note the multiple number of chewed corners.

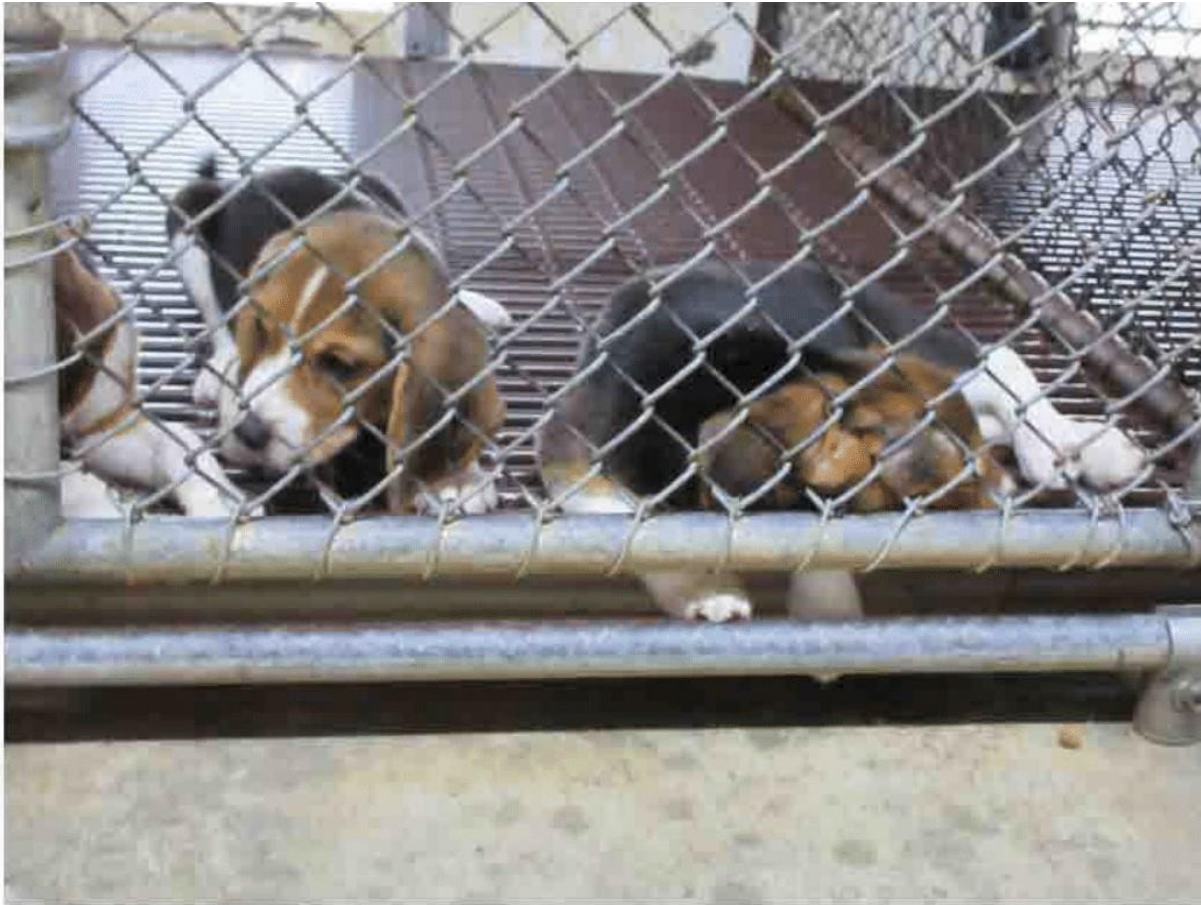
CFR:3.6(a)(2)(x)

Description: Building G2, Room 3, puppies with limbs that fall between the raised grate floor and the front gate to the kennel.

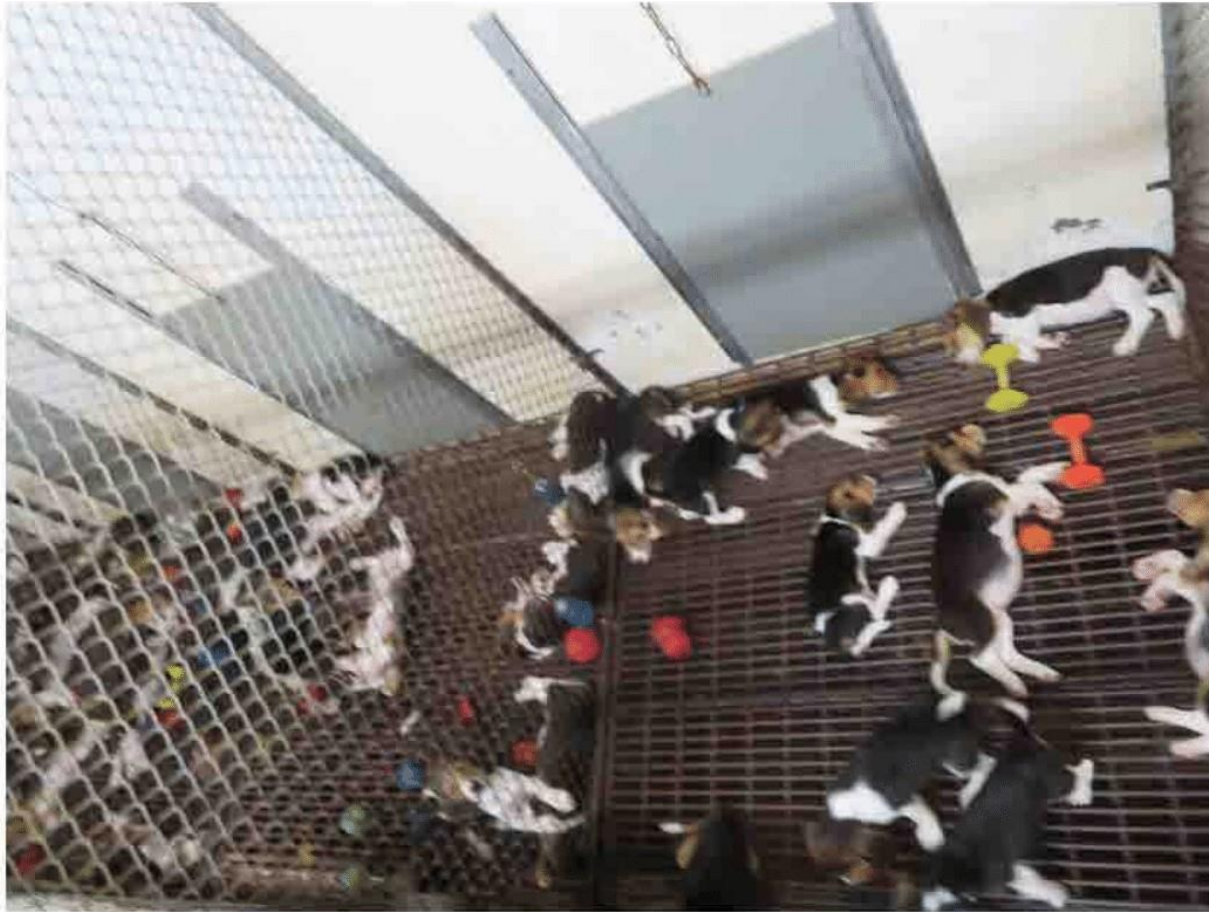
CFR:3.3(a)

Description: Temperature reading 84.6F in Building G2 with puppies around 11 AM (see photo 604 for temp)

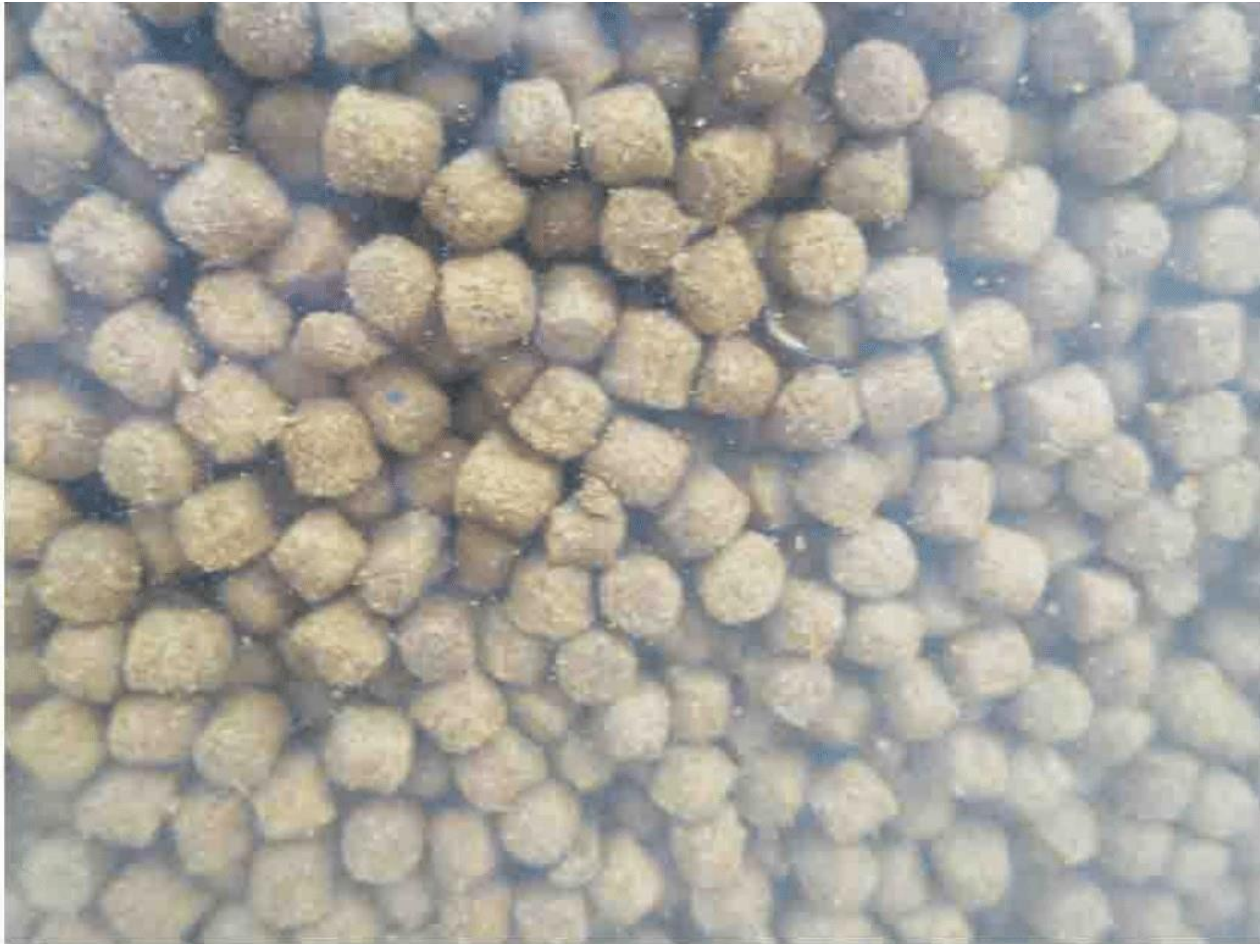
CFR:3.9(a)

Description: Small worm-type insects present in dry dog food hopper.

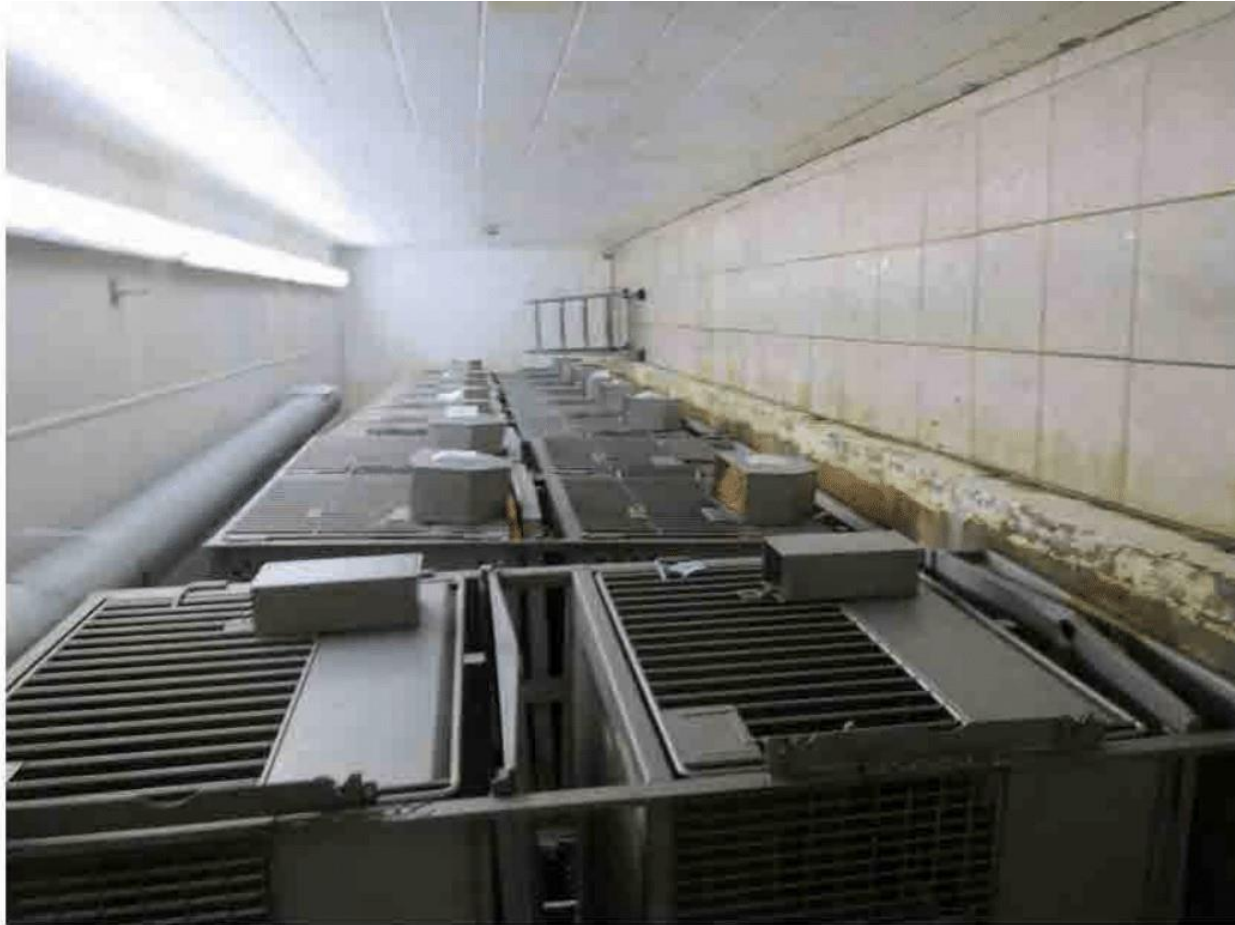
CFR:3.6(c)(1)(ii)

Description: Banks of cages that are too small for dams with medium and large litters

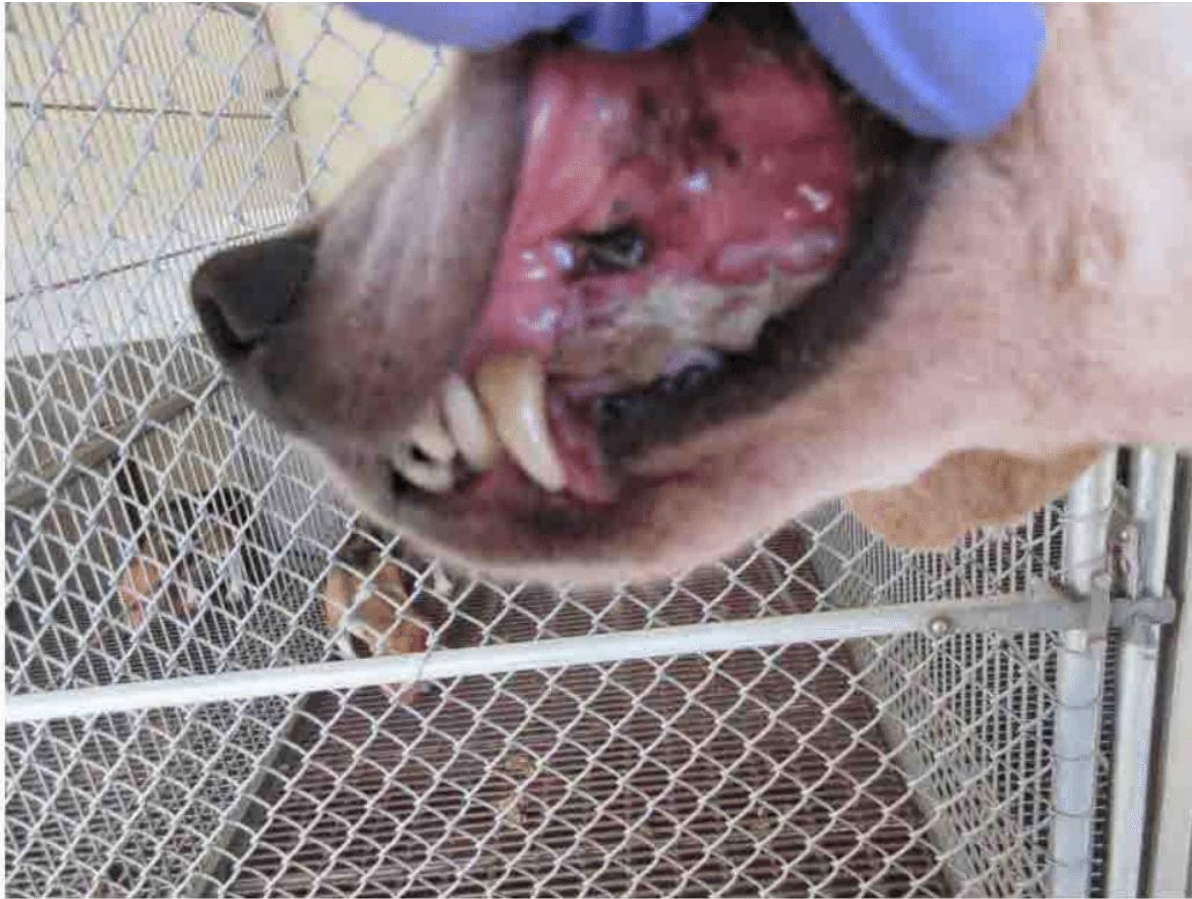
CFR:2.40(b)(3)

Description: One adult female beagle (CICCYS) in the broodstock area (Gemini 1, room #10) had severe dental disease. There was gingivitis, gum recession, and some hair in the tartar.

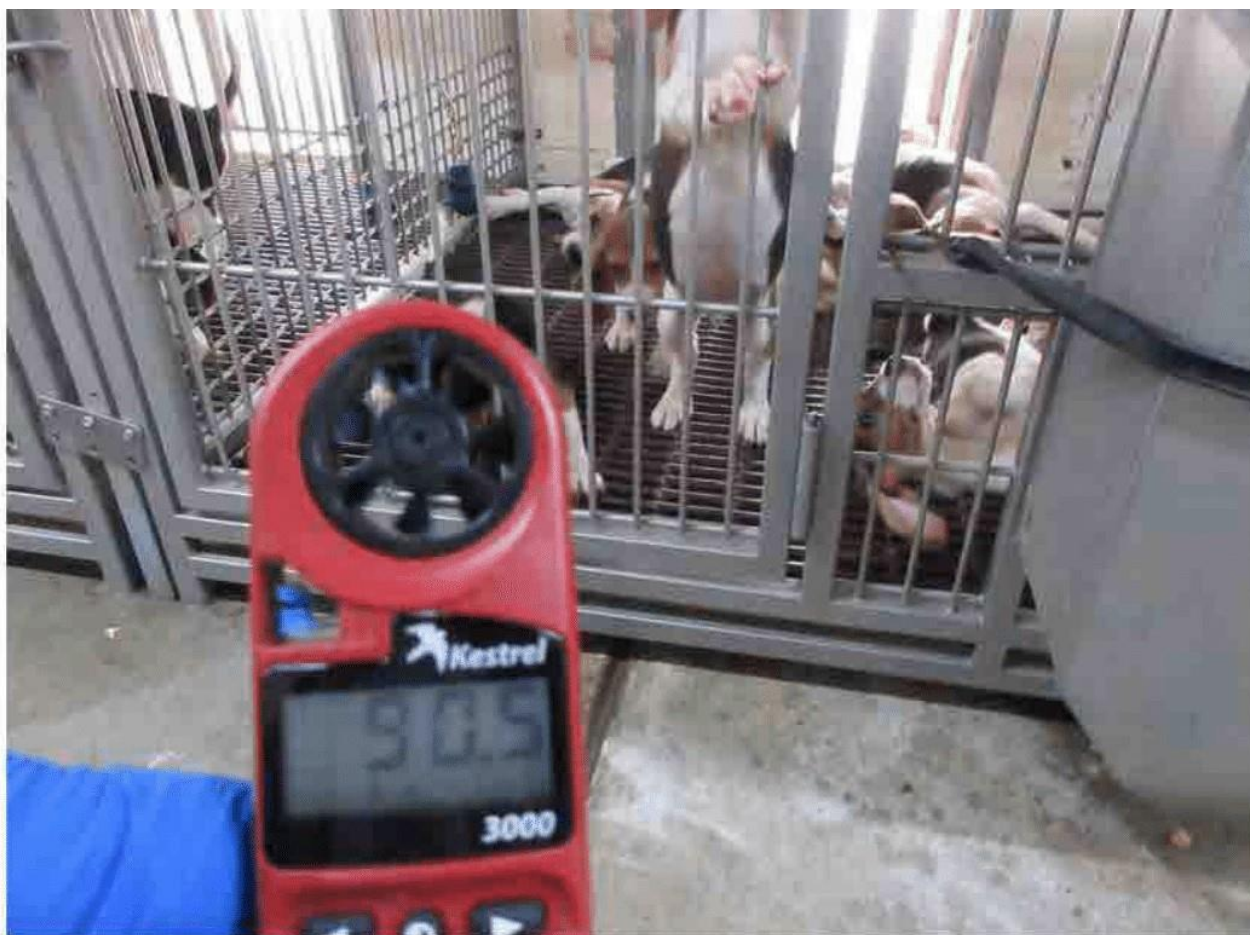
Description: G2, Room 3, at 2:36PM

CFR:3.3(a)

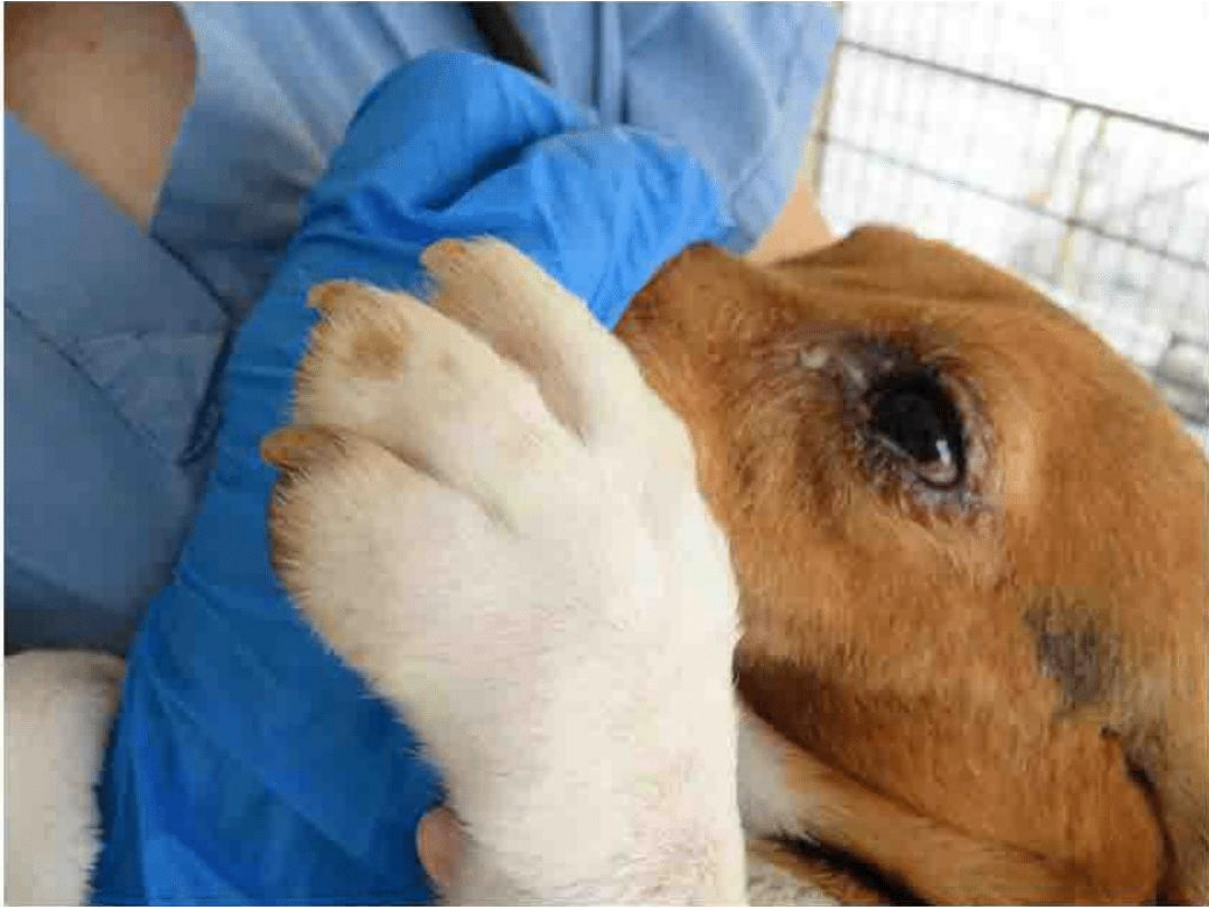
CFR:2.40(b)(3)

Description: In Building G2, Room 5, an adult male beagle (CMBCIA) has discharge in the left eye. The eye has milky, yellow discharge around the edges and there are crusts on the surrounding eyelid.

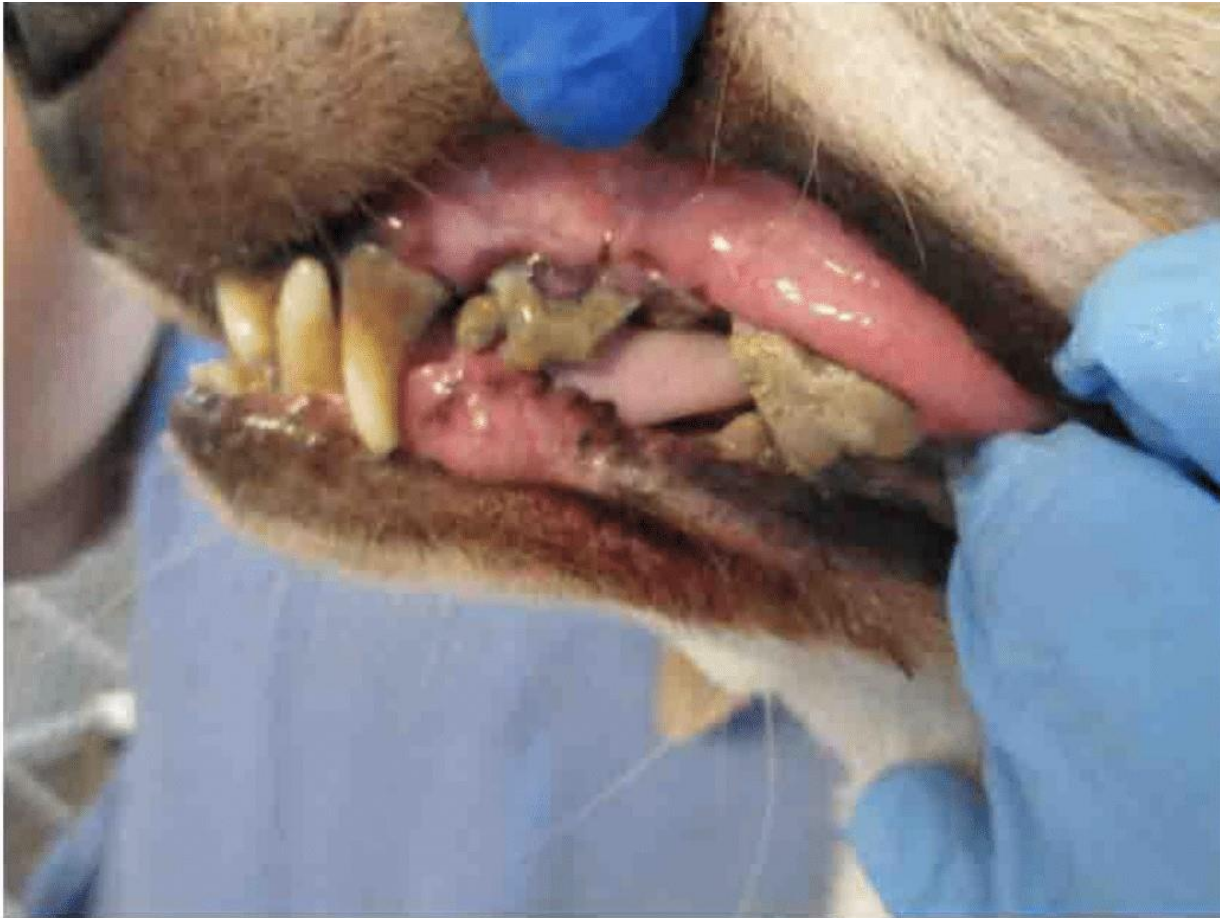
CFR:2.40(b)(3)

Description: One adult female beagle (CGASCD), located in Gemini 1, Room 3, Kennel #24, had severe dental disease and a skin issue.

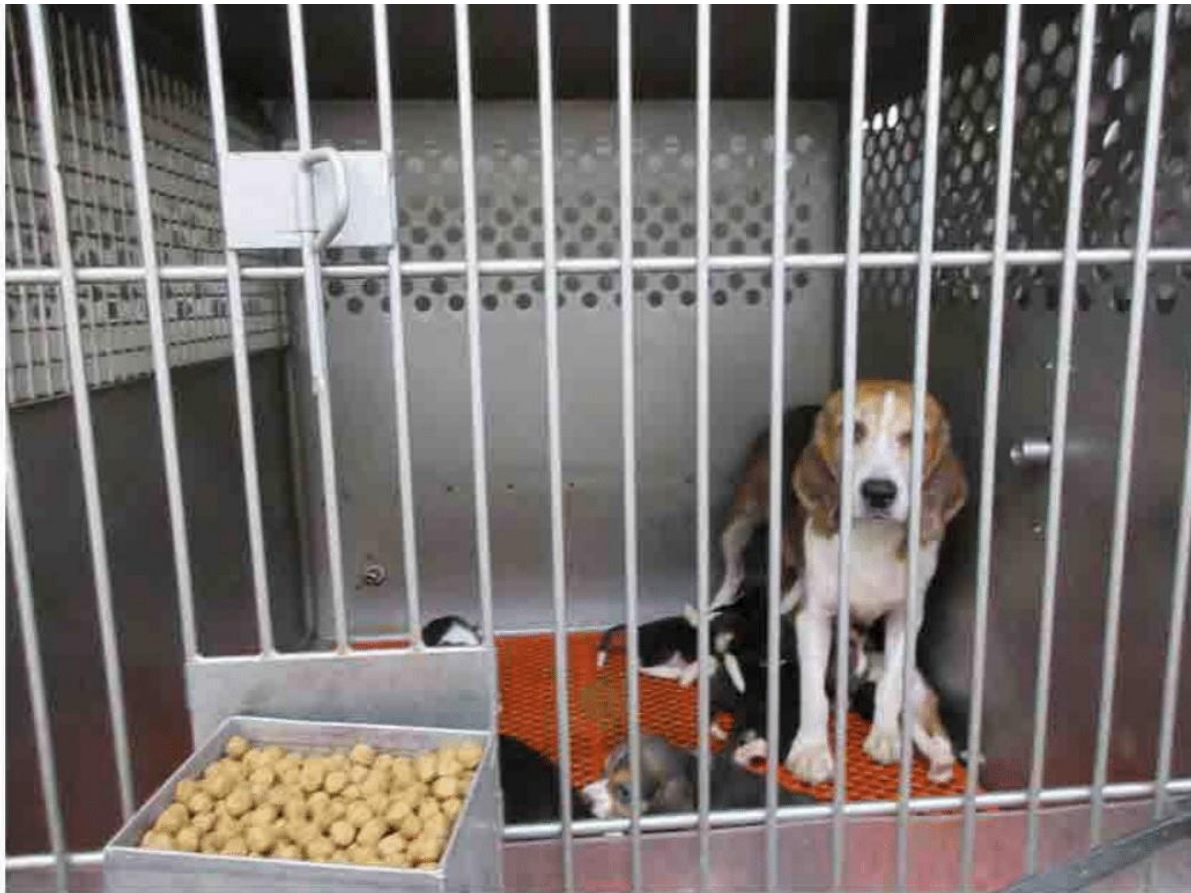
CFR:3.6(c)(1)(ii)

Description: CILCCX, female dog with 8 puppies in cage that is too small. Feces visible on floor of cage.

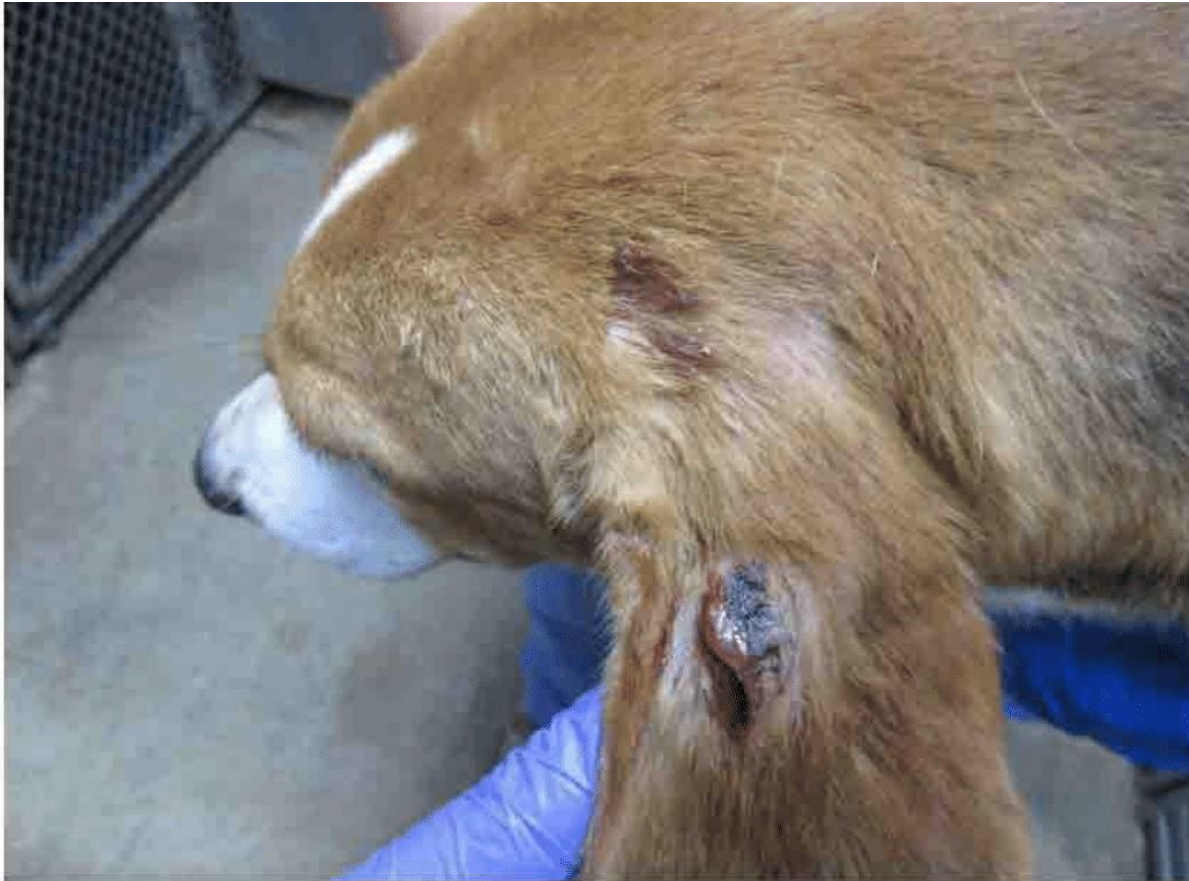
CFR:2.40(b)(3)

Description: One adult female beagle (CLGCST) located in Gemini 2, room 2, kennel #44, had a wound on the outer surface of her left ear.
