Certificate: 32-A-0774

Legal Name: ENVIGO RMS LLC

Inspection No: 2016090000667813

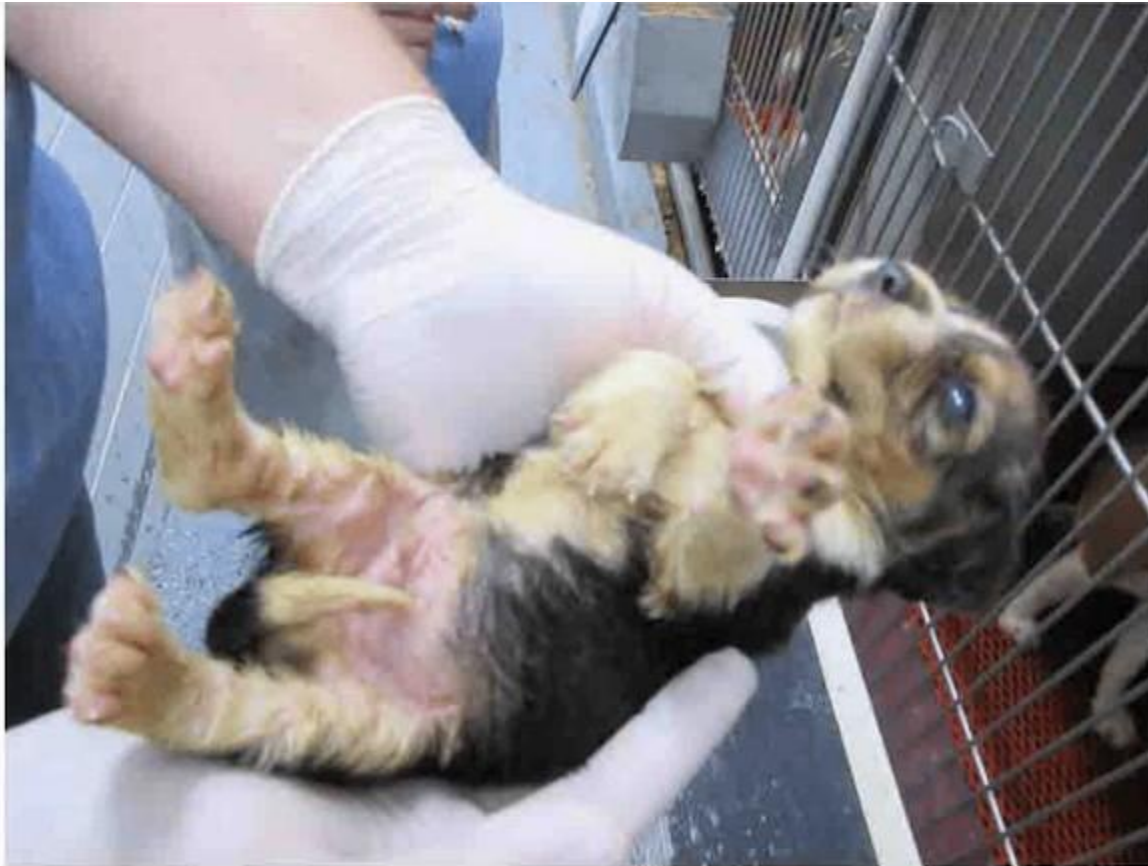
CFR:2.131(b)(1)

Description: A 3-week-old male puppy after being found in the fecal and urine waste pan below the cage housing his litter and dam. Video demonstrates the "skin tent" indicating dehydration. This photo was taken approx. 15 minutes after the puppy had been found and placed back in the cage with his dam.

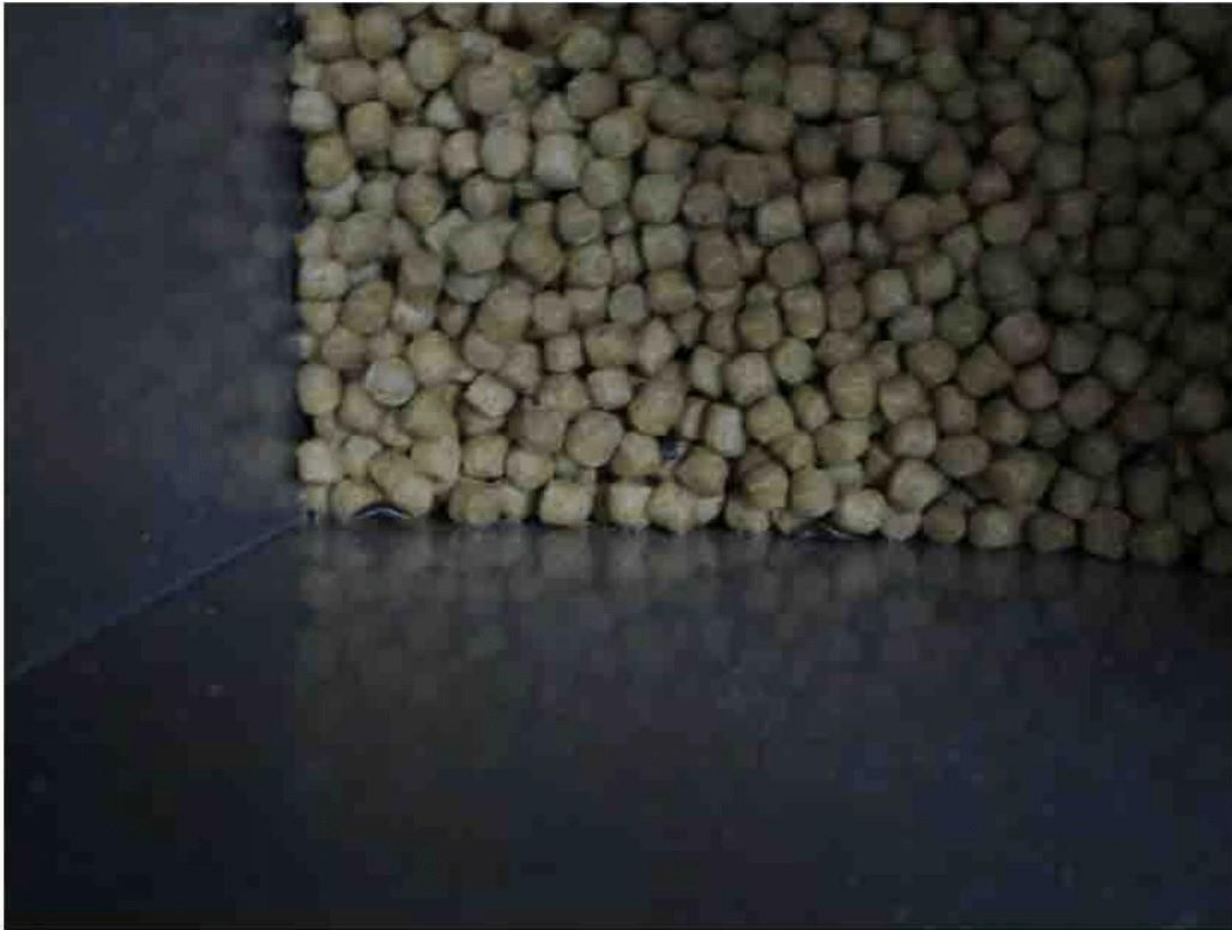
CFR:3.9(a)

Description: Small black worm-type insects present in dry dog food.

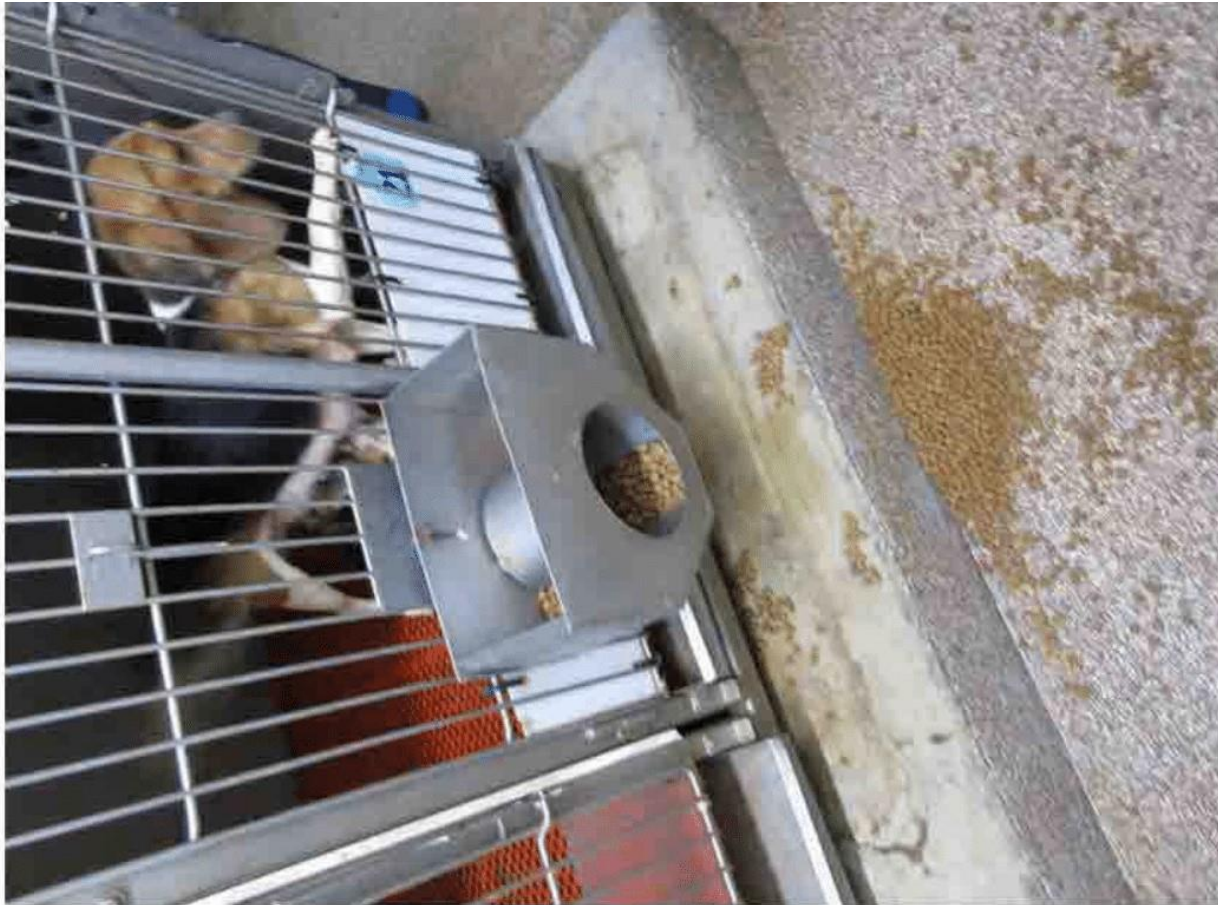
CFR:2.131(b)(1);3.9(a)

Description: Lactating dams and their puppies with no food access. Dam was seen to be reaching out and digging in her food container, and food was seen falling out on to the floor.

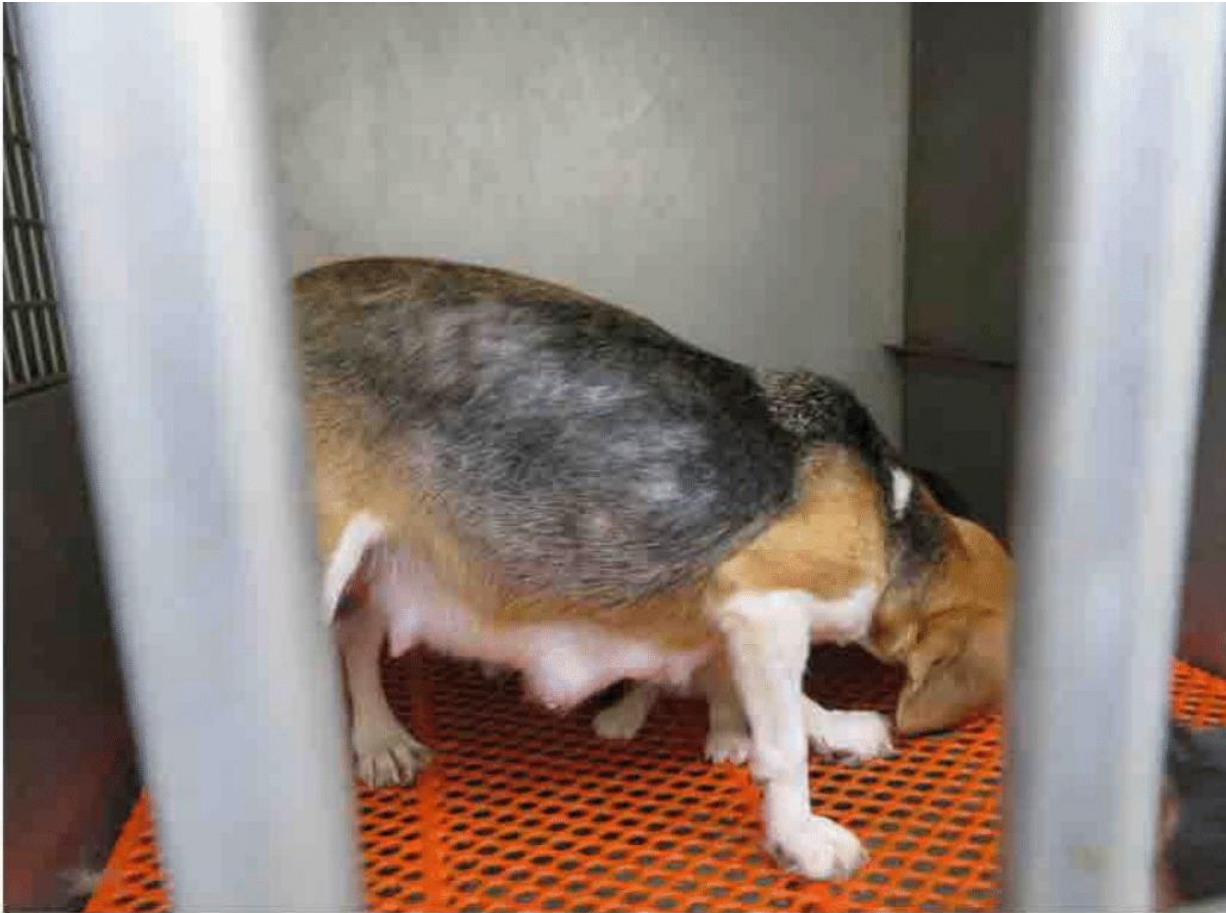
CFR:2.40(b)(3)

Description: One adult female beagle (CKKCPZ) had a skin issue. Patchy hair loss and scabs on sides of body.

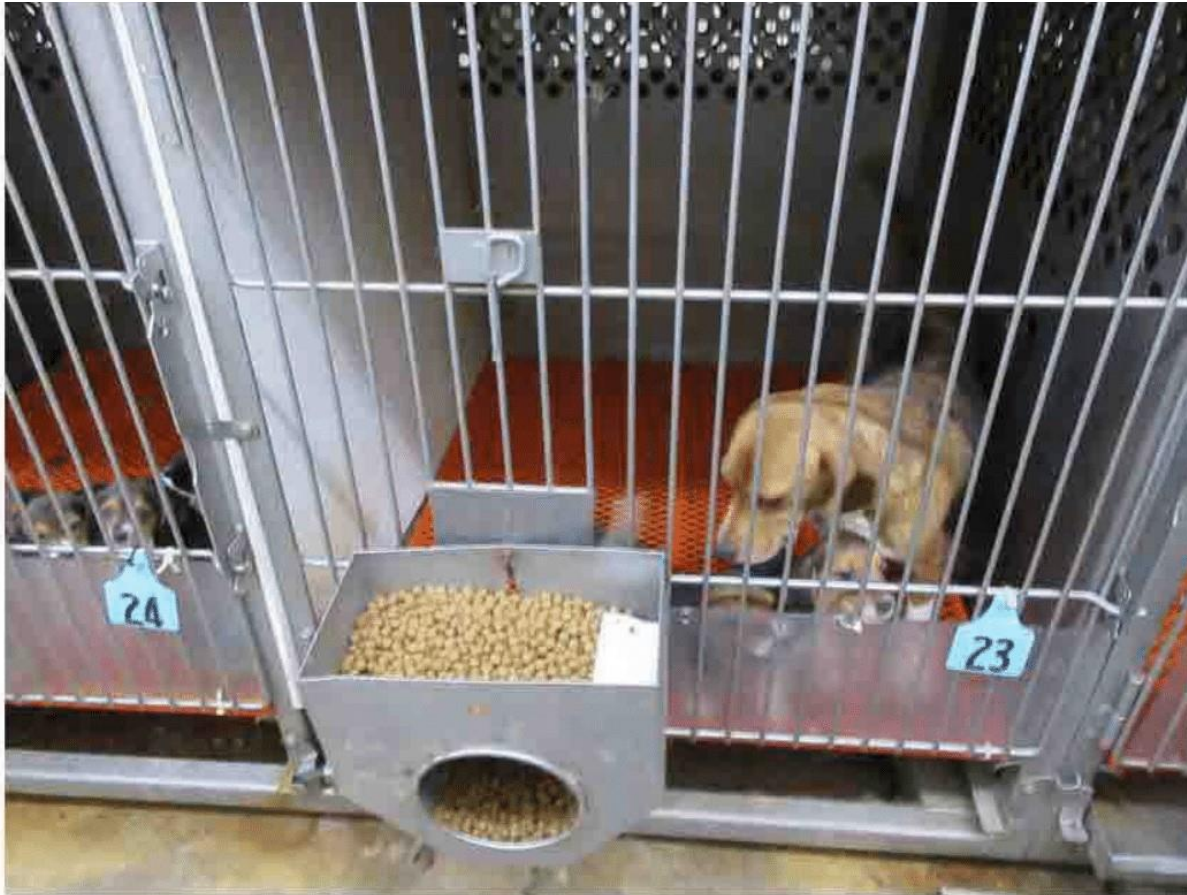
CFR:2.131(b)(1);3.9(a)

Description: Lactating dams and their puppies with no food access. Note dam is focusing on her food container.

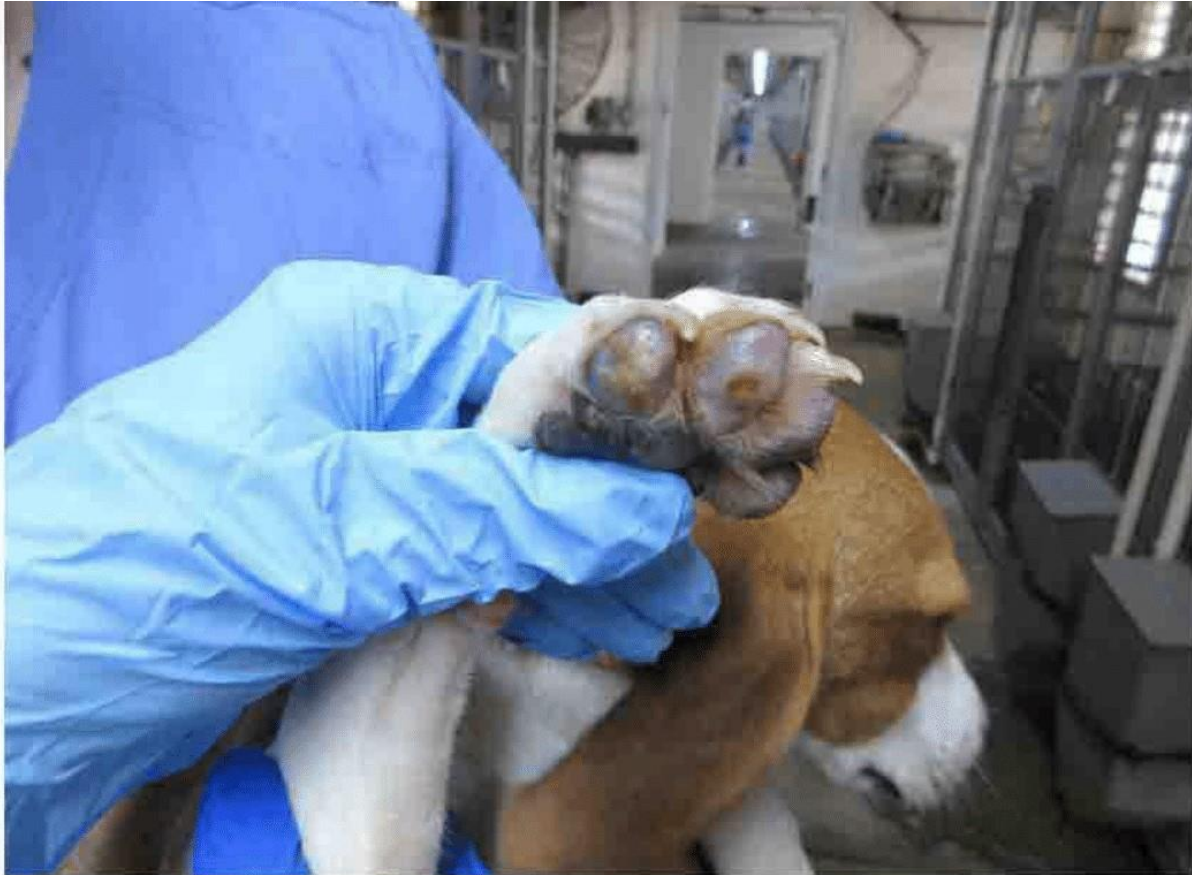
CFR:2.40(b)(3)

Description: One male puppy (CMCCIZ) located in Gemini 2, room 3, kennel #73, was reluctant to bear weight on the right front foot. The underside of each of the middle two toes on the front right foot had a small circular red area approximately 1/3 inch in diameter.

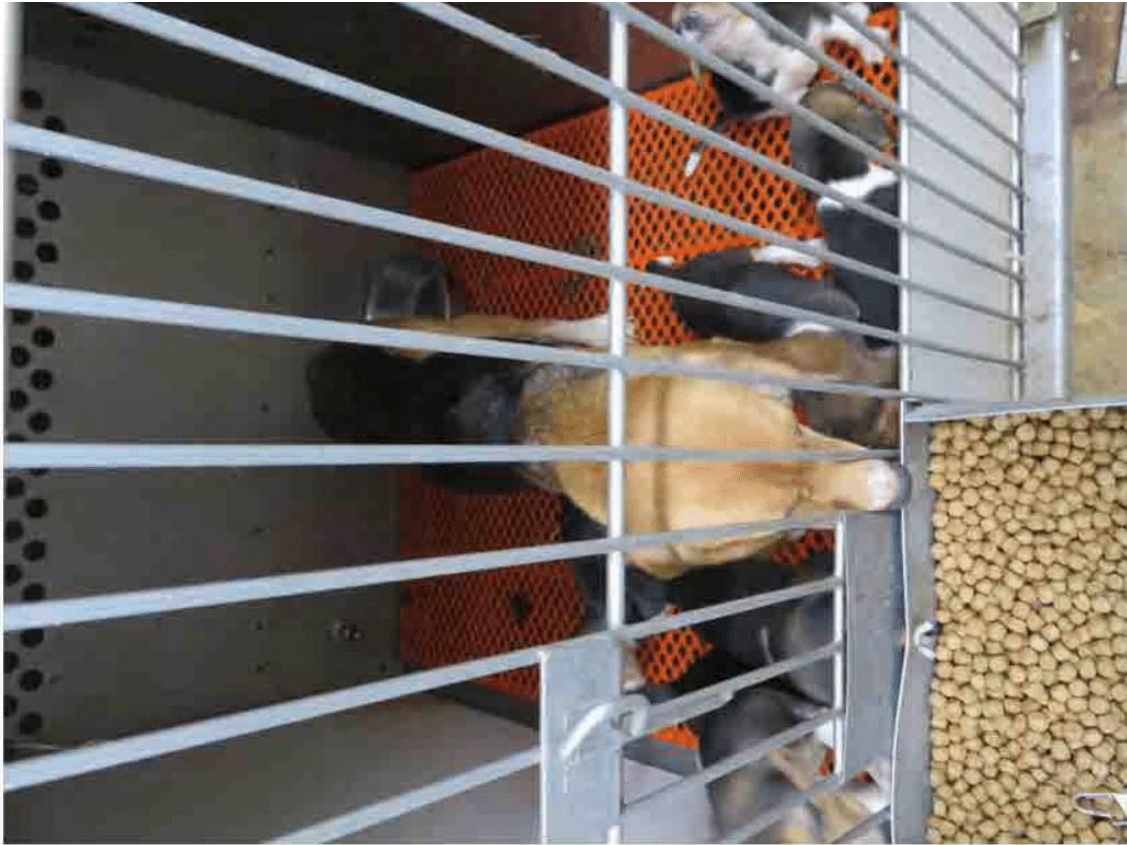
CFR:2.131(b)(1);3.9(a)

Description: Skinny dam with 6-week-old nursing puppies and no food access. Photo taken after approximately 24 hours without food. This dam had been previously identified by the AV as too skinny and was receiving canned food supplements (bowl in background). However, the canned food supplement was halted when she began the fasting protocol SOP to prevent mastitis.
